## Torinturk and Dalavich Notes

Torinturk, visited 26/8/2026

#### **Dalavich, visited 27/8/2026**

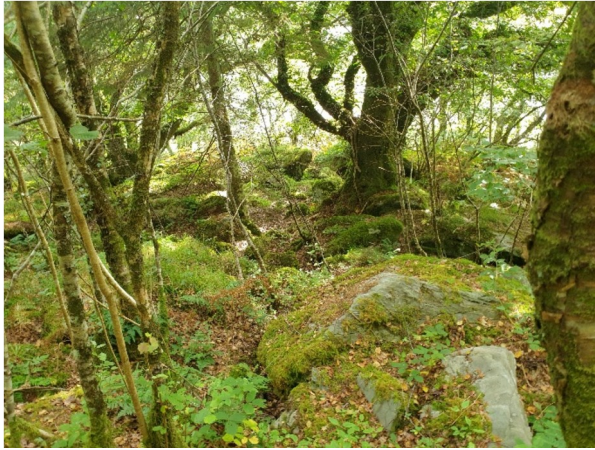
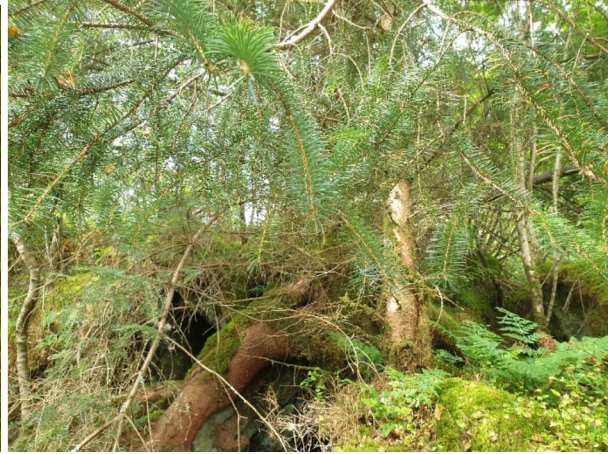
The lochside strip is mainly broadleaved and appears never to have been planted but there has been some self-seeding into it. The local group have been cutting out small trees (hand-tool work) but are not able to tackle the bigger trees. FLS will need to get their contractors to do this; ring barking probably not a good idea as it may stimulate heavy coning.

*Lochside strip; a big conifer that will need contractors to fell it.*

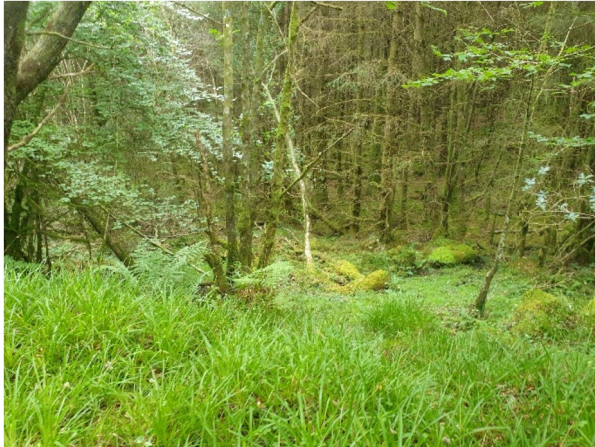
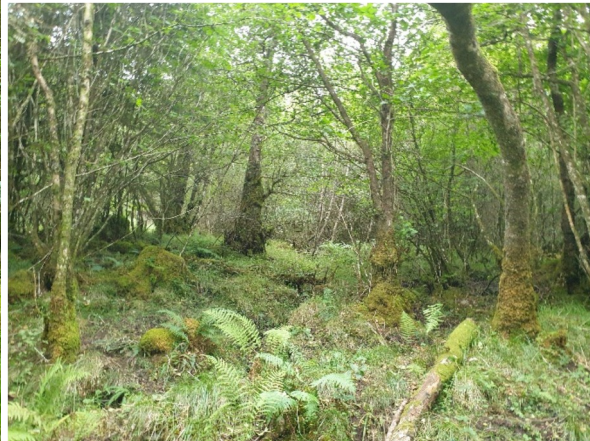
Small areas of wet ground within the conifer block, if ever planted failed and are now willow/birch. A few oaks were also left.

*Looking down into small wet hollow; old drain or small straightened stream*

Along the fringes of the lower woodland strip and along main stream courses, felling should ideally be done manually with as low a disturbance to the ground as possible. Consider felling to waste where extraction would be particularly difficult.

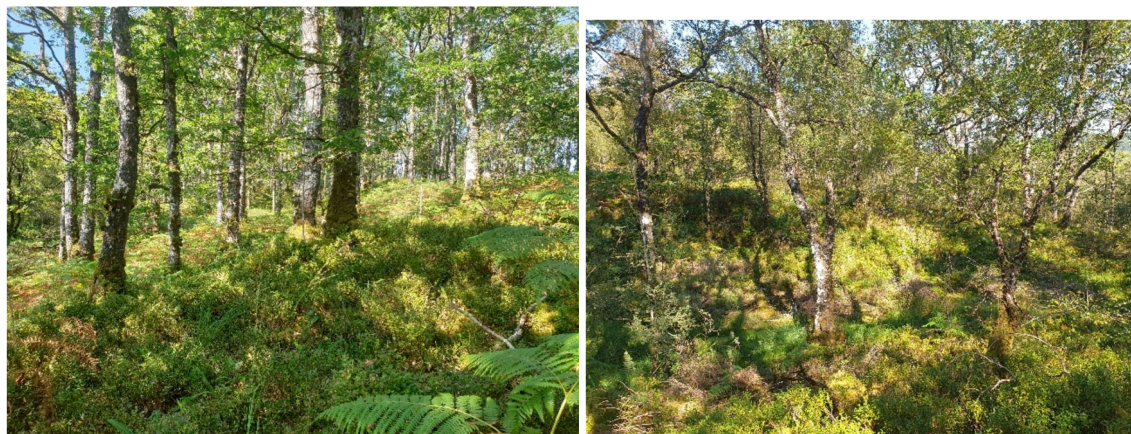
(a) Oakwood; (b) birch growth in area where conifer felled between 1986 and 1988.

My general impression of the site is that the vegetation is recovering well; restoration has been a success. There are not many mature conifers left. The areas where they were are predominantly birch and show up well on the Google Earth image.

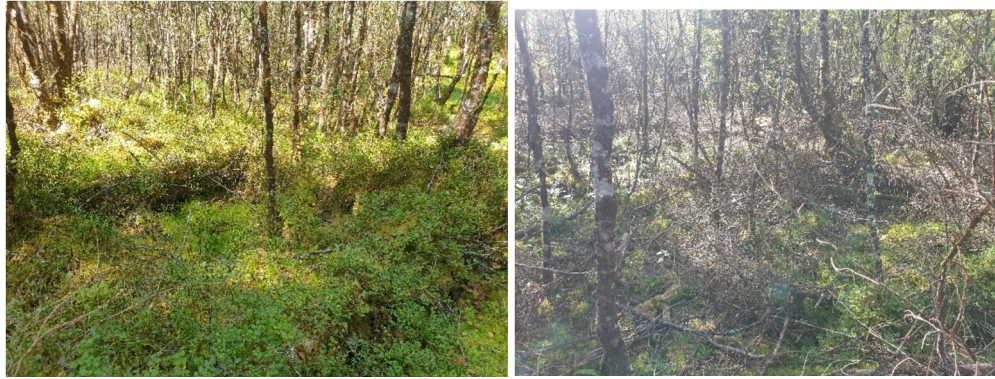
(c) Conifer felled to waste post 1988, now young birch; (d) signs of more recent cutting of conifer regeneration.

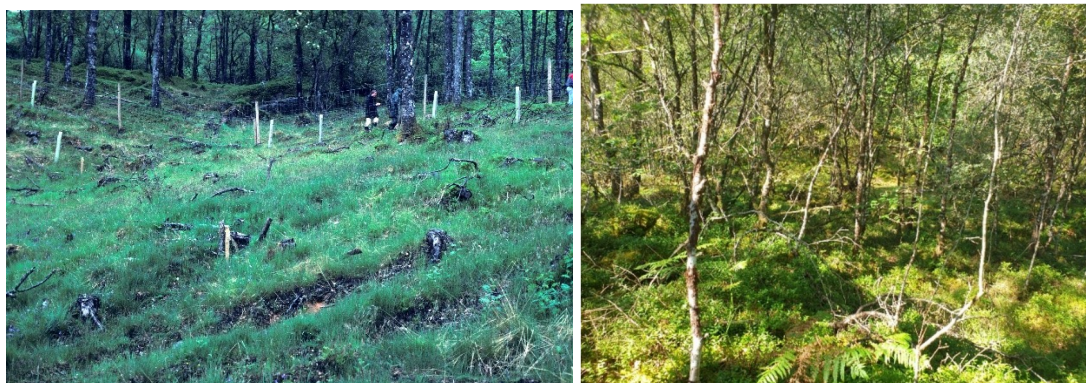
The small exclosure that was included in the May survey is still detectable as a local patch with a lot of young birch and rowan (about 2-3 cm dbh), although the fence has been taken down. Any younger regeneration than this seems to be being hammered by the deer. Snapped and browsed small rowan, birch and willow were noted. Oak seedlings were abundant, a phenomenon I have seen in various other woods across the country, generally reflecting the abundant mast in 2025. Where these occur under even small canopy gaps one option might be put in some small temporary deer fenced roundels, to let a group get away.

Former exclosure 1987, and now with the fence removed.

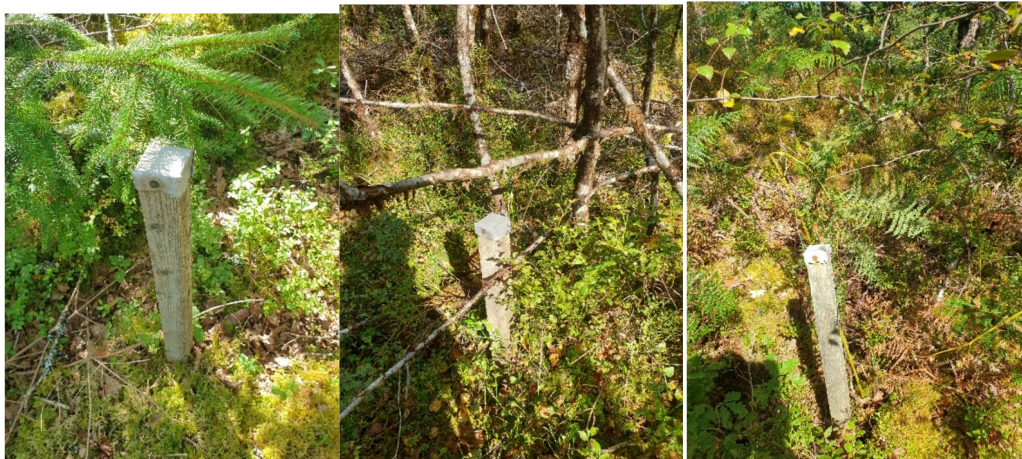
Posts N6;

We did find three surviving posts in the morning (I am now doubtful of our fourth candidate plot which was a round post by the stream) which were offset from my GIS positions in a fairly consistent way.

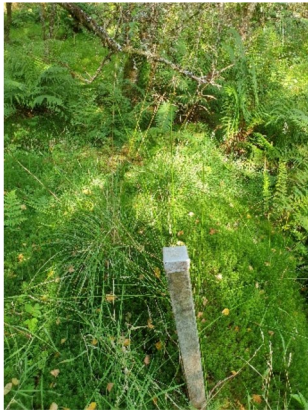
Posts H9

In the afternoon, I went back and found another two, again somewhat offset, plus a streamside one of the standard 2x2 square timber type, but much more offset. The discrepancies may be because I have not managed to interpret Janet's map precisely enough.
